**Flood Control Project Maintenance
Levee Inspections**

Fall 2012 Levee Maintenance Deficiency Summary Report

Reclamation District No. 0150 Merrit Island

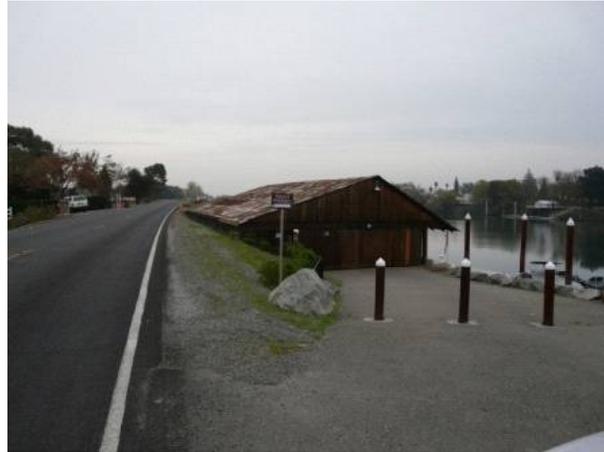
Levee Mile Report Line	2
Start Levee Mile	0.16
End Levee Mile	0.16
Location	Water Side
Category	Earthen Levee
Item	Encroachments
Building located on waterside of levee at LM 0.16	
pkazi_f_20120913_633.JPG

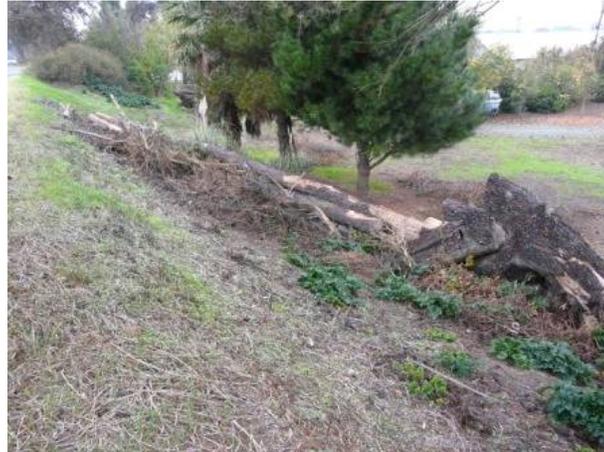
Levee Mile Report Line	6
Start Levee Mile	0.27
End Levee Mile	0.27
Location	Land Side
Category	Earthen Levee
Item	Encroachments
Remove tree branches from landside of levee at LM 0.27	
pkazi_f_20120913_646.JPG

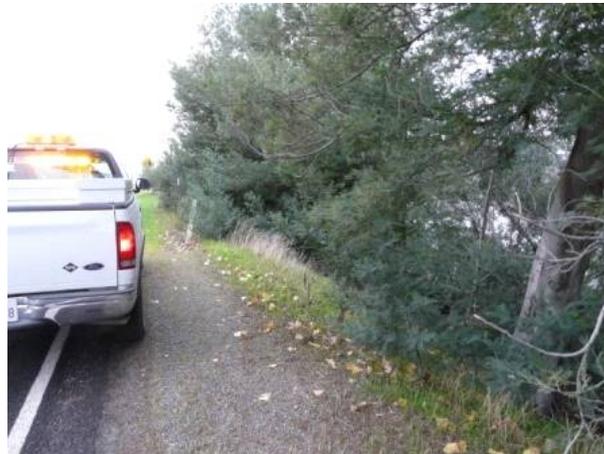
Levee Mile Report Line	11
Start Levee Mile	0.59
End Levee Mile	0.59
Location	Water Side
Category	Earthen Levee
Item	Trim / Thin Trees
Trim trees above 5' from surface of the waterside of the levee within 20' from shoulder at LM 0.59	
pkazi_f_20120913_635.JPG

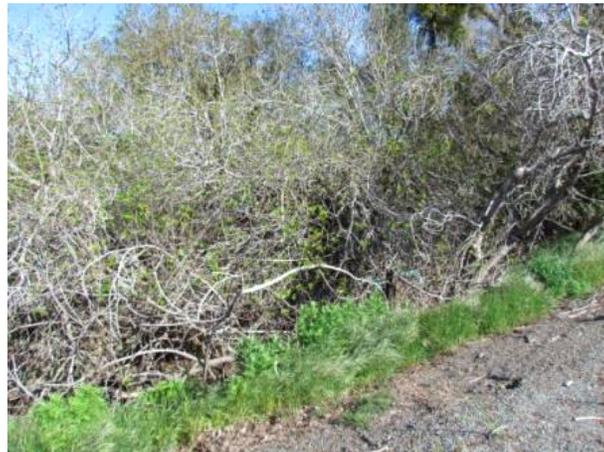
Levee Mile Report Line	13
Start Levee Mile	0.98
End Levee Mile	0.98
Location	Land Side
Category	Earthen Levee
Item	Trim / Thin Trees
Overgrown trees were obstructing the landside slope of the levee looking upstream.	
pkazi_f_20120913_608.jpg

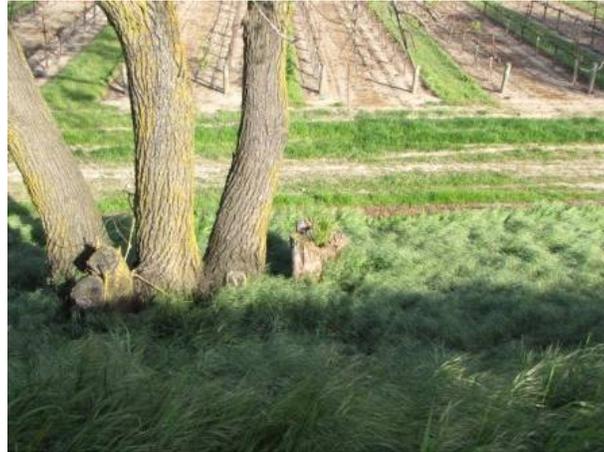
Levee Mile Report Line	14
Start Levee Mile	1.16
End Levee Mile	1.16
Location	Land Side
Category	Earthen Levee
Item	Trim / Thin Trees
View of a tree stump on the landward slope.	
pkazi_f_20120913_605.jpg

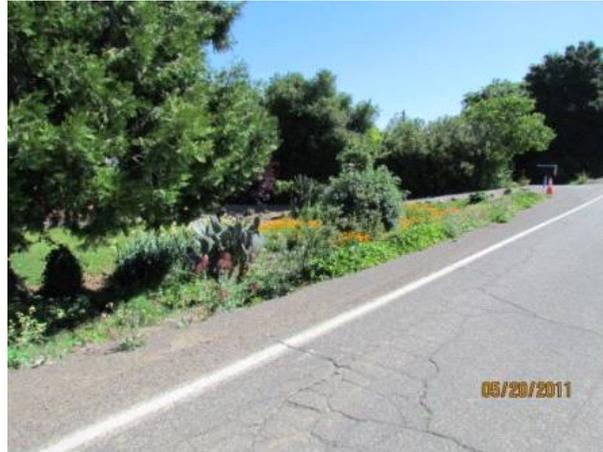
Levee Mile Report Line	18
Start Levee Mile	2.31
End Levee Mile	2.33
Location	Land Side
Category	Earthen Levee
Item	Vegetation
<p>Landscaping was found on the landside of the levee. The picture was taken from the crown looking upstream.</p>	
<p>pkazi_f_20120913_644.jpg</p>

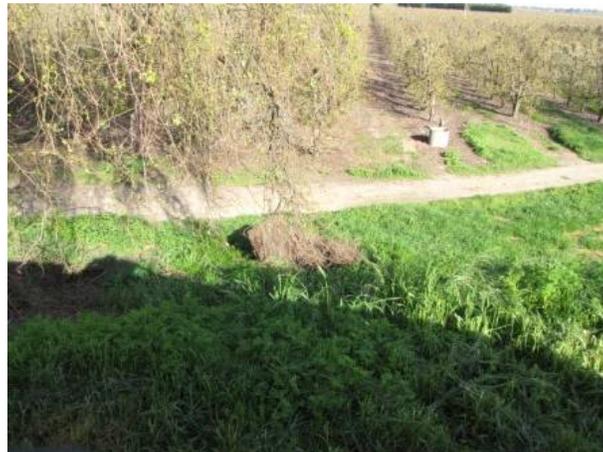
Levee Mile Report Line	21
Start Levee Mile	2.80
End Levee Mile	2.80
Location	Land Side
Category	Earthen Levee
Item	Trim / Thin Trees
<p>View of a tree stump on the landward slope.</p>	
<p>pkazi_f_20120913_610.jpg</p>

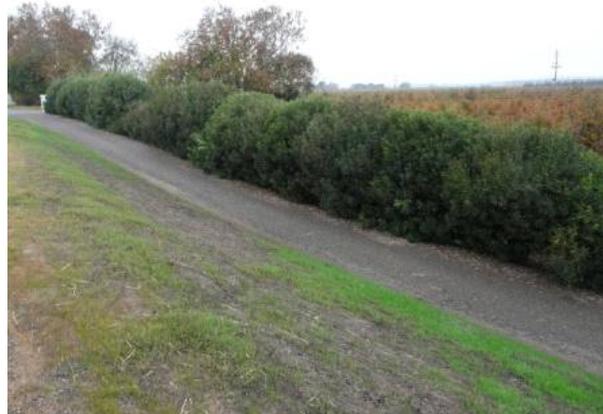
Levee Mile Report Line	24
Start Levee Mile	3.02
End Levee Mile	3.06
Location	Land Side
Category	Earthen Levee
Item	Vegetation
Landscaping providing a screen for a residence on landside of levee from LM 3.02 to LM 3.06	
pkazi_f_20120913_643.JPG

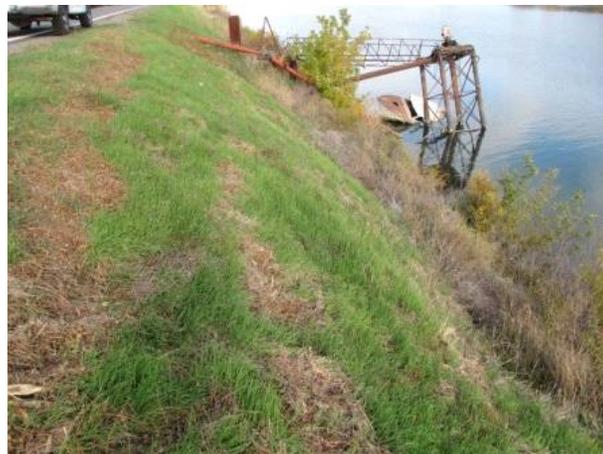
DWR ID: DWR_RD0150_02_s_2012_85										
25	3.29	3.29	Earthen Levee	Erosion / Bank Caving	WS	M Ma	E2 : Schedule repair of erosion site prior to the next inspection. Inspector Comments: Depressions into the waterward slope can be seen along the waterward slope at this site. Also note the damaged pump support, pump, and pipe just upstream of the site; they may contribute to the erosion in a high water event and should be removed.	38.355321 ° -121.530902 °	38.355321 ° -121.530902 °	961 Y
DWR ID: DWR_RD0150_02_s_2012_961										
26	3.35	3.35	Earthen Levee	Vegetation	LS	M Ma	V4 : Elderberries are blocking visibility and flood fight capability.	38.355979 ° -121.530288 °	38.355979 ° -121.530288 °	17 Y
DWR ID: DWR_RD0150_02_s_2012_17										
27	3.56	3.56	Earthen Levee	Encroachments	CR	M En	PI : Pipe Inspector Comments: PVC pipe was used for pumping the water.	38.358152 ° -121.527579 °	38.358152 ° -121.527579 °	15 Y

Levee Mile Report Line	25
Start Levee Mile	3.29
End Levee Mile	3.29
Location	Water Side
Category	Earthen Levee
Item	Erosion / Bank Caving
View of erosion on the waterward slope looking upstream. Depressions into the slope can be seen in several places.	
pkazi_f_20120913_648.jpg

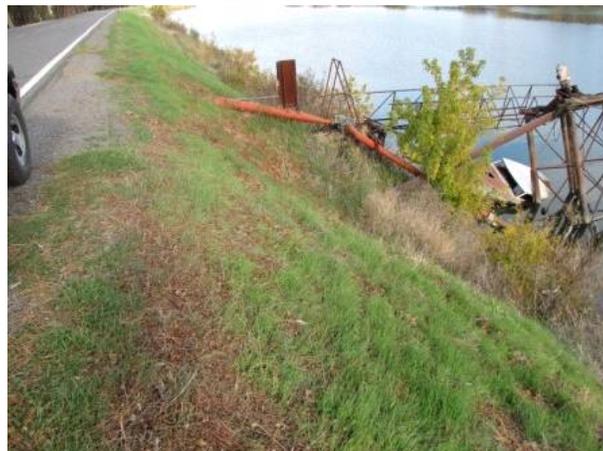
Levee Mile Report Line	25
Start Levee Mile	3.29
End Levee Mile	3.29
Location	Water Side
Category	Earthen Levee
Item	Erosion / Bank Caving
Additional view of erosion on the waterward slope looking upstream. Note the damaged pump support, pump, and pipe just upstream of the site.	
pkazi_f_20120913_649.jpg

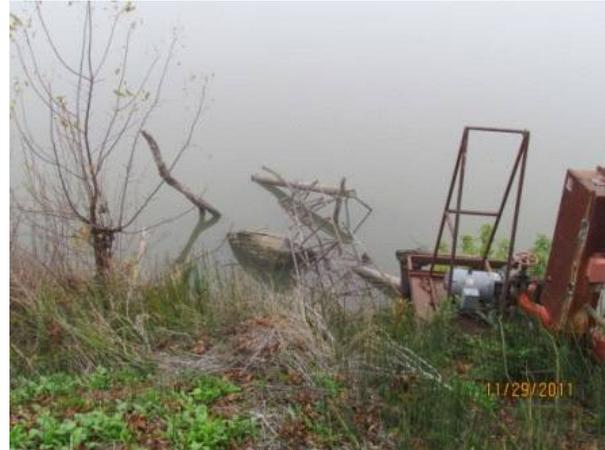
pkazi_f_20120913_650.jpg

View of the erosion site, and broken pump support along with a boat on the waterside of the levee. The picture was taken from the crown looking towards the toe of the levee during fall 2011 inspection.

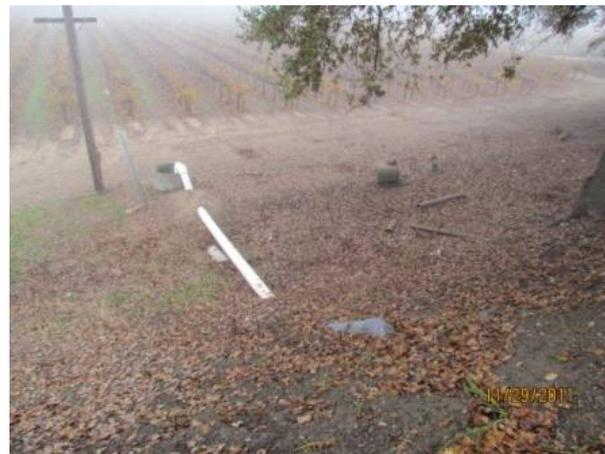
pkazi_f_20120913_611.jpg

PVC pipe was used under the levee crown for irrigation purpose. The picture was taken from the crown looking downstream.

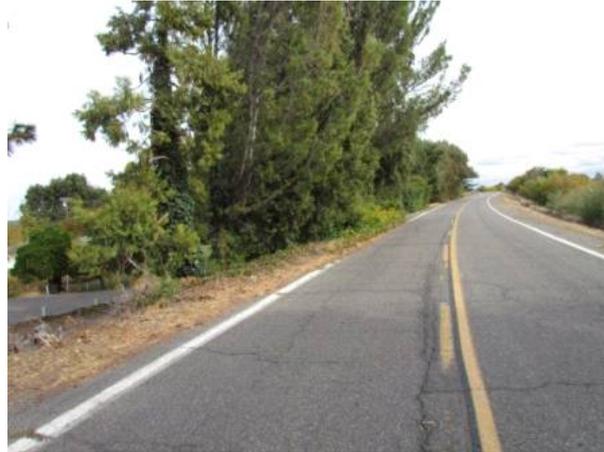
Levee Mile Report Line	28
Start Levee Mile	3.60
End Levee Mile	3.73
Location	Land Side
Category	Earthen Levee
Item	Vegetation
Landscaping was blocking the visibility on the landside of the levee looking upstream.	
pkazi_f_20121102_004.jpg

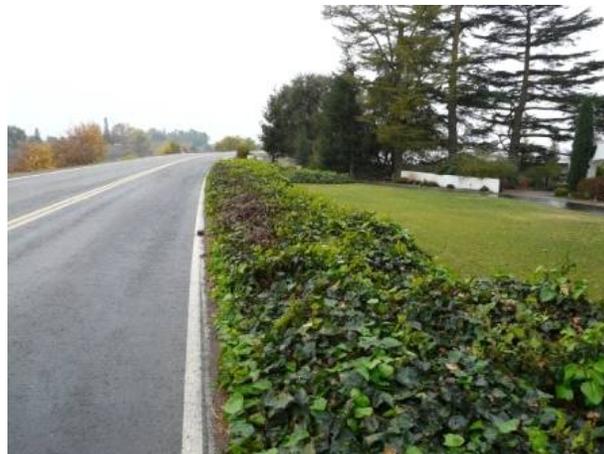
Levee Mile Report Line	29
Start Levee Mile	3.90
End Levee Mile	3.93
Location	Land Side
Category	Earthen Levee
Item	Vegetation
Landscaping in front of a residence on landside of levee from LM 3.90 to LM 3.93. The levee in this location is greater than 100' wide.	
pkazi_f_20120913_642.JPG

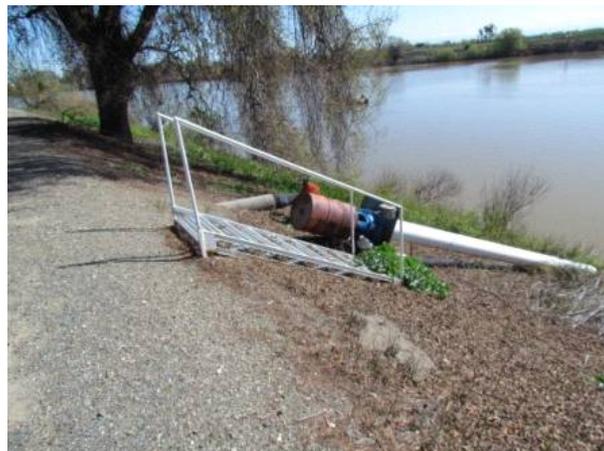
Levee Mile Report Line	30
Start Levee Mile	3.94
End Levee Mile	3.94
Location	Water Side
Category	Earthen Levee
Item	Encroachments
A stairway was found on the waterside slope of the levee.	
pkazi_f_20120913_623.jpg

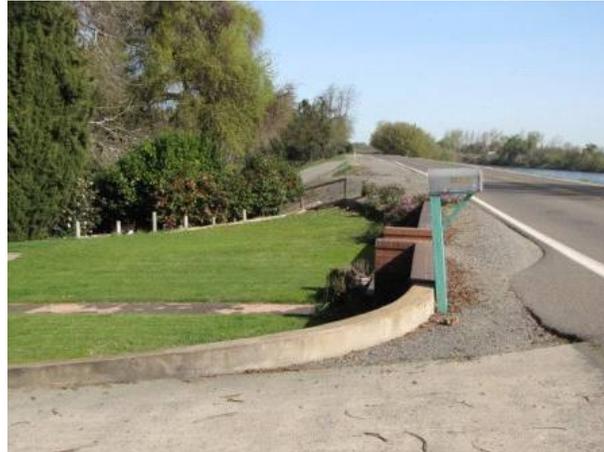
Levee Mile Report Line	31
Start Levee Mile	4.15
End Levee Mile	4.16
Location	Land Side
Category	Earthen Levee
Item	Encroachments
View of a retaining wall on the landward slope looking upstream.	
pkazi_f_20120913_615.jpg

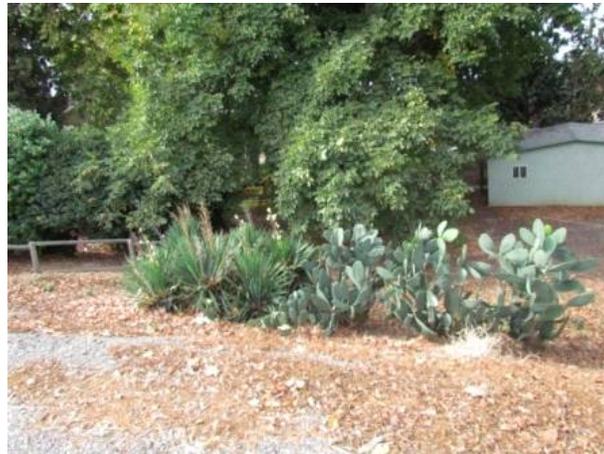
Levee Mile Report Line	32
Start Levee Mile	4.17
End Levee Mile	4.17
Location	Land Side
Category	Earthen Levee
Item	Vegetation
View of cacti on the landside of the levee looking from the crown.	
pkazi_f_20121102_005.jpg

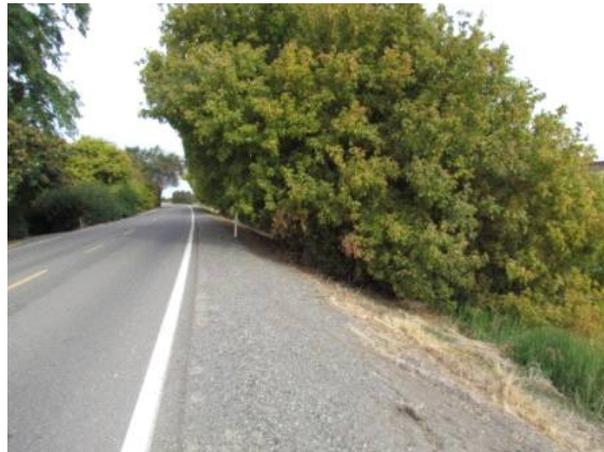
Levee Mile Report Line	33
Start Levee Mile	4.31
End Levee Mile	4.31
Location	Water Side
Category	Earthen Levee
Item	Trim / Thin Trees
Overgrown tree was obstructing the visibility on the waterside slope of the levee looking upstream.	
pkazi_f_20121102_006.jpg

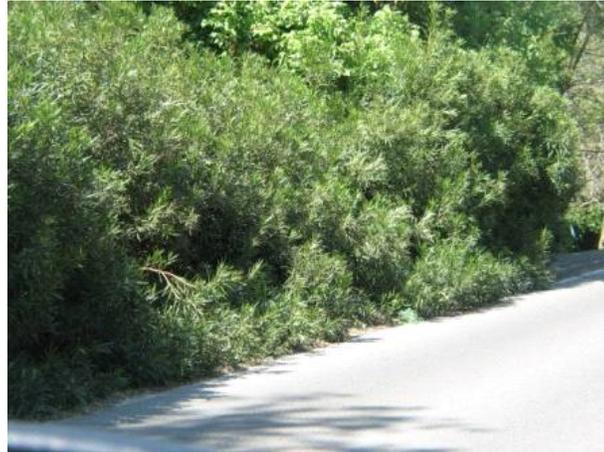
Levee Mile Report Line	34
Start Levee Mile	4.33
End Levee Mile	4.35
Location	Land Side
Category	Earthen Levee
Item	Vegetation
Landscaping (Oleander) on landward slope from 4.33 to 4.35	
pkazi_f_20120913_618.jpg

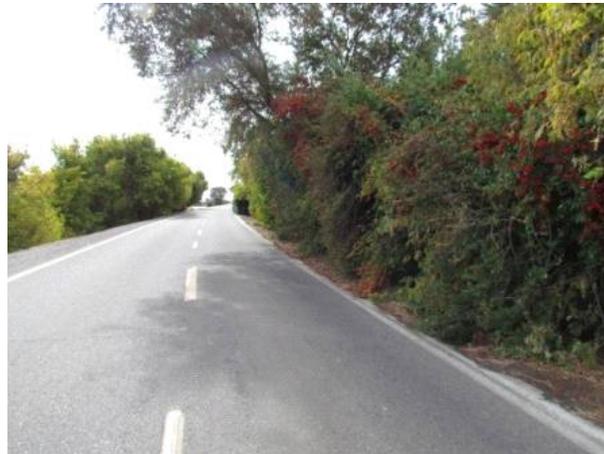
Levee Mile Report Line	35
Start Levee Mile	4.37
End Levee Mile	4.41
Location	Land Side
Category	Earthen Levee
Item	Vegetation
Trees were obstructing the views on the landside slope of the levee looking downstream.	
pkazi_f_20121102_007.jpg

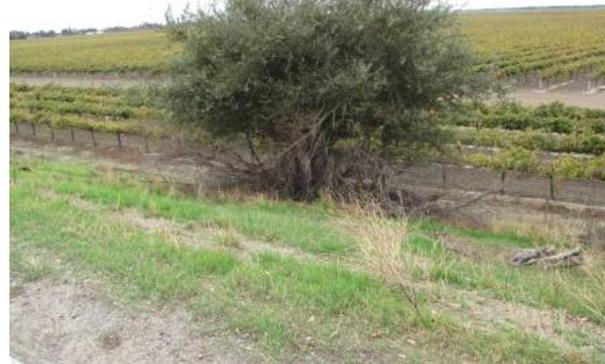
Levee Mile Report Line	38
Start Levee Mile	4.68
End Levee Mile	4.68
Location	Land Side
Category	Earthen Levee
Item	Trim / Thin Trees
View of a tree on the landward slope with lower branches blocking visibility and access. Most of these branches appear to already be dead and should be removed.	
pkazi_f_20120913_656.jpg

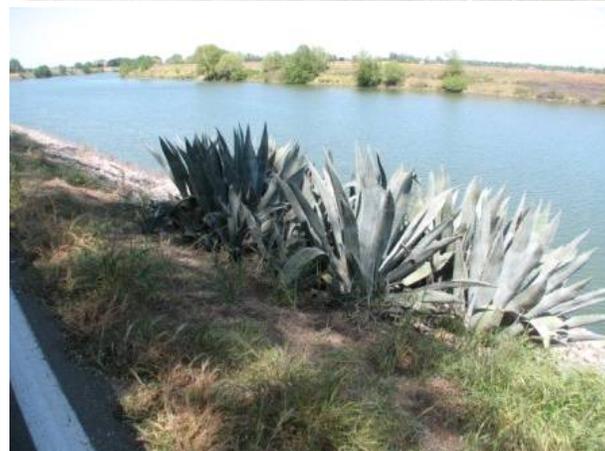
Levee Mile Report Line	39
Start Levee Mile	4.76
End Levee Mile	4.76
Location	Water Side
Category	Earthen Levee
Item	Vegetation
Century plant on waterward slope at LM 4.76	
pkazi_f_20120913_621.jpg

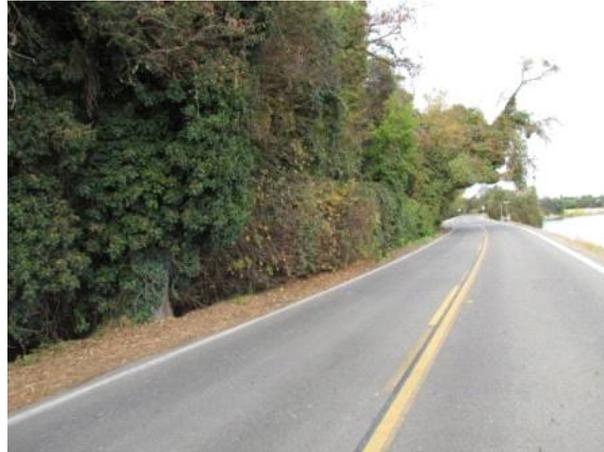
pkazi_f_20121102_008.jpg

Trees were obstructing the views on the landside slope of the levee looking upstream.

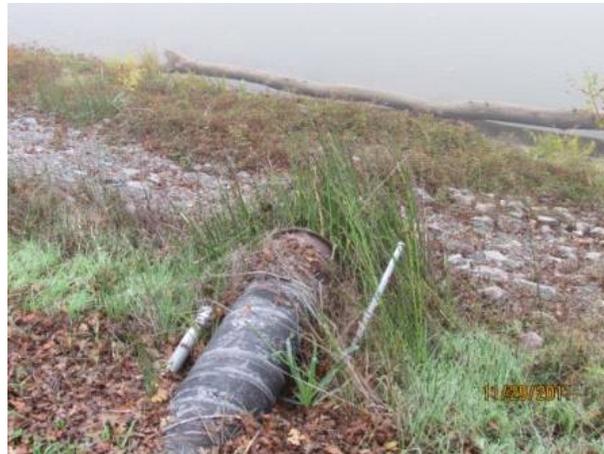
Levee Mile Report Line	41
Start Levee Mile	4.95
End Levee Mile	4.95
Location	Water Side
Category	Earthen Levee
Item	Encroachments

End of the pipe was not welded properly to perform as a closure device. The picture was taken from the crown looking upstream.

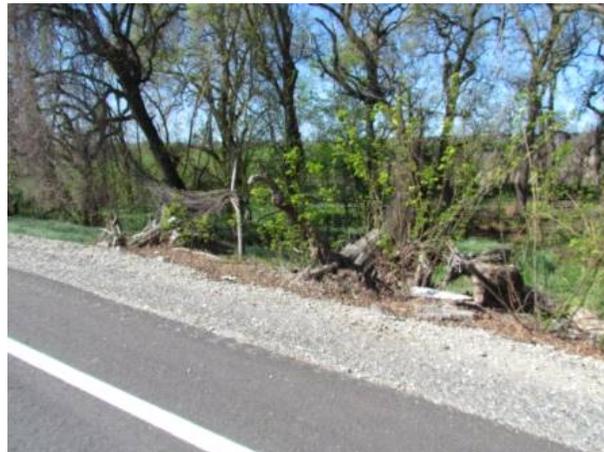
Levee Mile Report Line	42
Start Levee Mile	4.98
End Levee Mile	4.98
Location	Land Side
Category	Earthen Levee
Item	Trim / Thin Trees

Tree stumps were found on the landside of the levee looking from the crown.

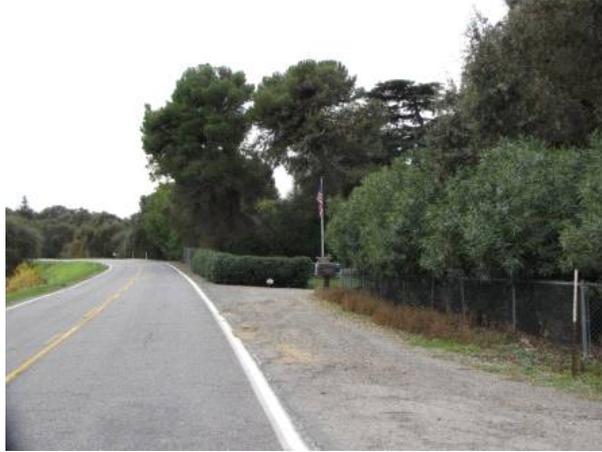
pkazi_f_20120913_641.jpg

View of landscaping along the landward shoulder and slope looking downstream.

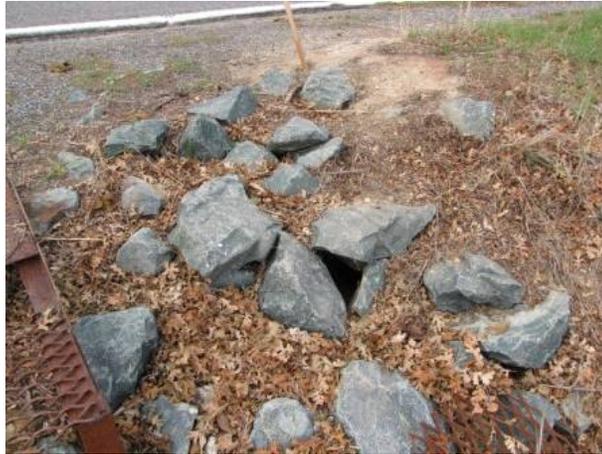
Levee Mile Report Line	46
Start Levee Mile	5.33
End Levee Mile	5.33
Location	Water Side
Category	Earthen Levee
Item	Slope Stability

View of rock placed on a pipe penetration on the waterward slope. Cavities can be seen under the rocks.

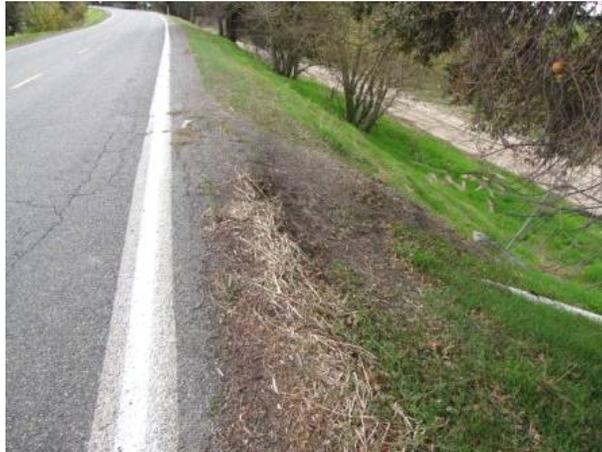
Levee Mile Report Line	47
Start Levee Mile	5.33
End Levee Mile	5.33
Location	Land Side
Category	Earthen Levee
Item	Slope Stability

47	5.33	5.33	Earthen Levee	Slope Stability	LS	M Ma	S1 : Repair slope instability. Inspector Comments: Depression in the landward slope at the shoulder over an irrigation pipe.	38.381126 ° -121.524207 °	38.381126 ° -121.524207 °	975 Y
DWR ID: DWR_RD0150_02_s_2012_975										
48	5.47	5.49	Earthen Levee	Vegetation	LS	M En	V6 : Landscaping	38.382675 ° -121.522367 °	38.382793 ° -121.522164 °	74
DWR ID: DWR_RD0150_02_s_2012_74										
49	5.55	5.57	Earthen Levee	Trim / Thin Trees	LS	C Ma	T2 : Thin trees to allow visibility of the ground and room to flood fight.	38.383320 ° -121.521259 °	38.383575 ° -121.520835 °	44
DWR ID: DWR_RD0150_02_s_2012_44										
50	5.81	5.81	Earthen Levee	Encroachments	WS	C Ma	DE : Debris Inspector Comments: Tires on the waterward slope.	38.385654 ° -121.517535 °	38.385654 ° -121.517535 °	965
DWR ID: DWR_RD0150_02_s_2012_965										
51	5.83	5.83	Earthen Levee	Encroachments	LS	C Ma	DE : Debris	38.385788 ° -121.517406 °	38.385788 ° -121.517406 °	41

View of a minor depression along the landward slope of the levee over a pipe penetration looking downstream.

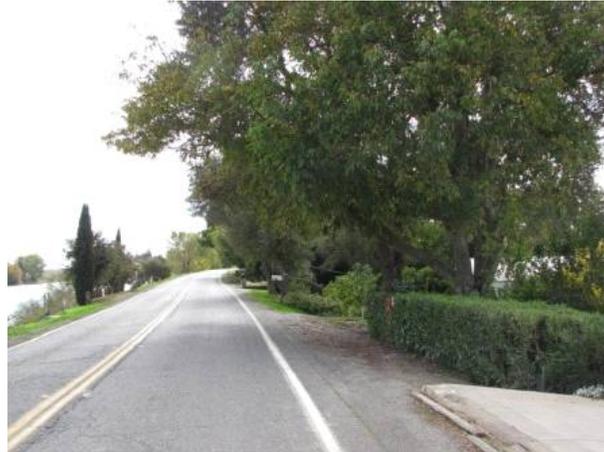
pkazi_f_20120913_640.jpg

View of landscaping along the waterward shoulder and slope looking downstream.

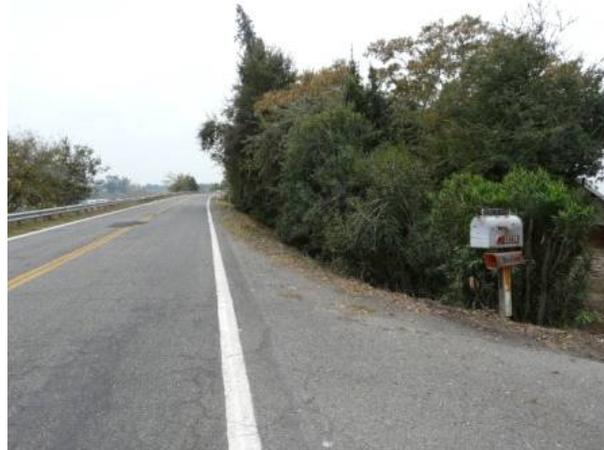
Levee Mile Report Line	65
Start Levee Mile	6.93
End Levee Mile	7.05
Location	Land Side
Category	Earthen Levee
Item	Vegetation
Landscaping providing a screen for a residence on landside of levee from LM 6.93 to LM 7.05	
pkazi_f_20120913_638.JPG

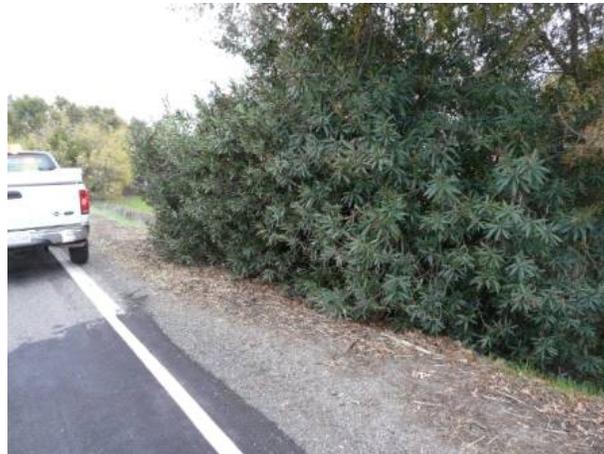
Levee Mile Report Line	66
Start Levee Mile	7.12
End Levee Mile	7.12
Location	Land Side
Category	Earthen Levee
Item	Vegetation
Landscaping providing a screen for a residence on landside of levee at LM 7.12	
pkazi_f_20120913_637.JPG

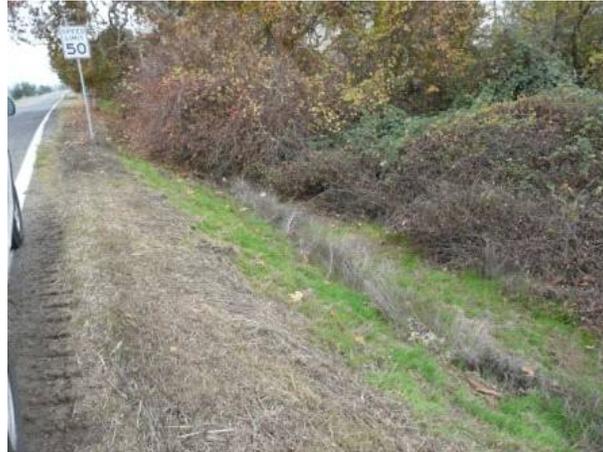
Levee Mile Report Line	71
Start Levee Mile	7.36
End Levee Mile	7.41
Location	Land Side
Category	Earthen Levee
Item	Trim / Thin Trees
Trim/thin trees and brush on landside of levee from LM 7.36 to LM 7.41	
pkazi_f_20120913_632.JPG

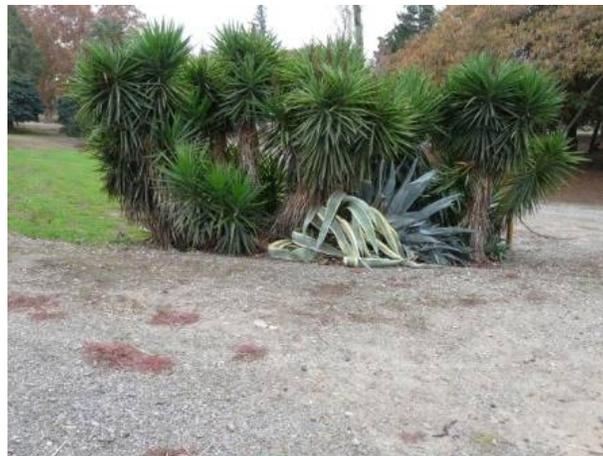
Levee Mile Report Line	72
Start Levee Mile	7.92
End Levee Mile	7.92
Location	Land Side
Category	Earthen Levee
Item	Vegetation
Landscaping on landside of levee at LM 7.92	
pkazi_f_20120913_636.JPG

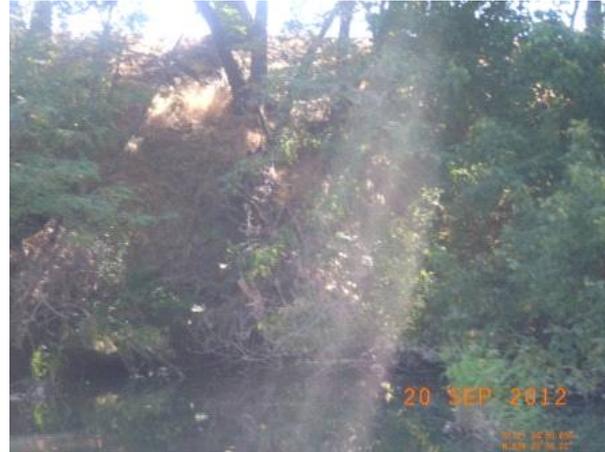
Levee Mile Report Line	4
Start Levee Mile	0.00
End Levee Mile	9.40
Location	Water Side
Category	Supplemental
Item	USACE Erosion Survey
USACE 2012 Photo #1	
USACE2012_ELK_0-2_L_1.jpg

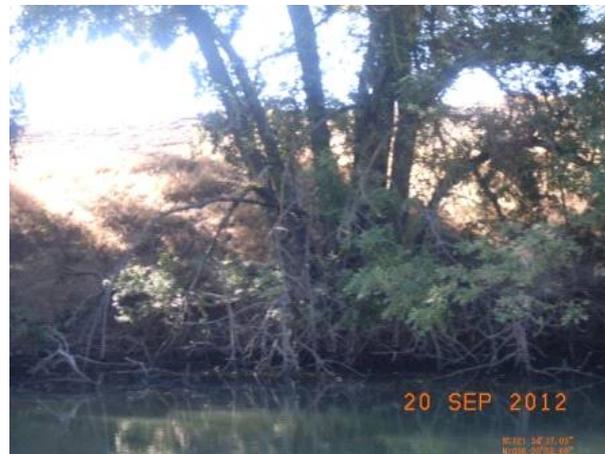
Levee Mile Report Line	4
Start Levee Mile	0.00
End Levee Mile	9.40
Location	Water Side
Category	Supplemental
Item	USACE Erosion Survey
USACE 2012 Photo #2	
USACE2012_ELK_0-2_L_2.jpg

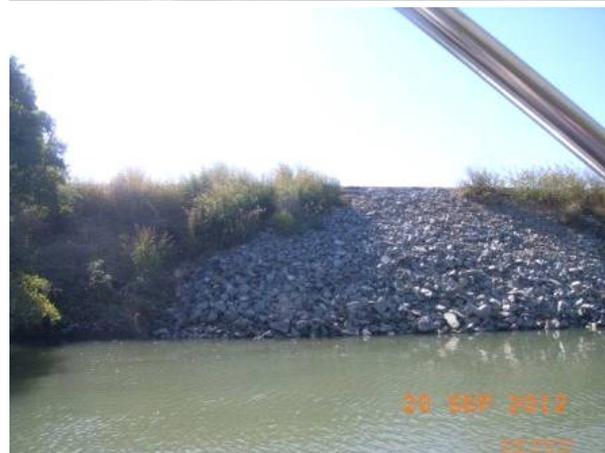
Levee Mile Report Line	4
Start Levee Mile	0.00
End Levee Mile	9.40
Location	Water Side
Category	Supplemental
Item	USACE Erosion Survey
USACE 2012 Photo #3	
USACE2012_ELK_0-2_L_3.jpg

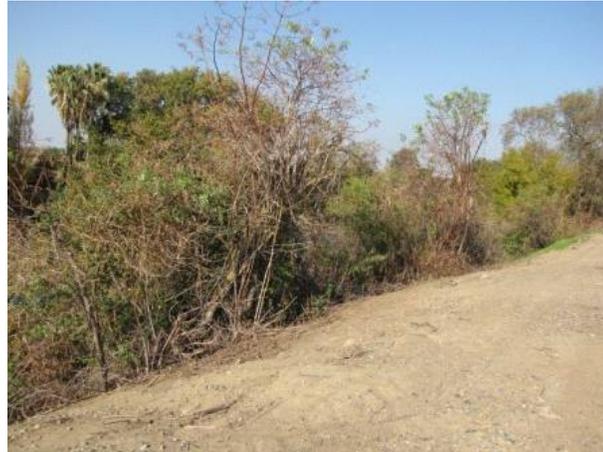
Levee Mile Report Line	5
Start Levee Mile	0.11
End Levee Mile	0.11
Location	Water Side
Category	Earthen Levee
Item	Vegetation
View of elderberry bush within 20 feet of shoulder blocking visibility and access.	
pkazi_f_20120913_750.jpg

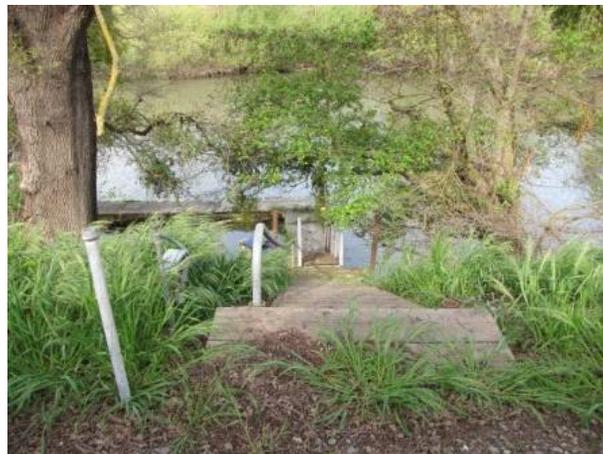
Levee Mile Report Line	6
Start Levee Mile	0.36
End Levee Mile	0.36
Location	Water Side
Category	Earthen Levee
Item	Encroachments
View of steps, a dock, and associated utilities on the waterward slope.	
pkazi_f_20120913_658.jpg

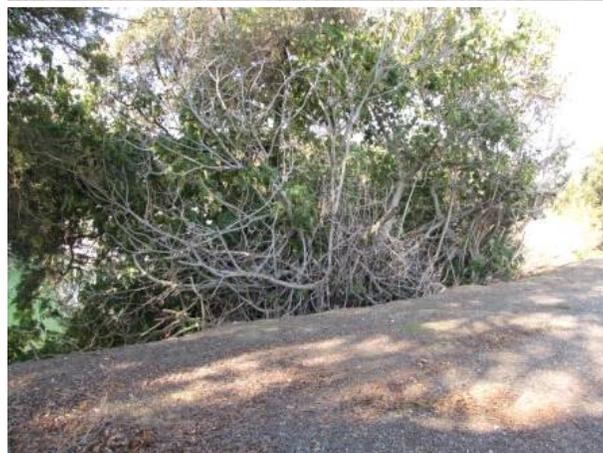
Levee Mile Report Line	8
Start Levee Mile	0.56
End Levee Mile	0.56
Location	Water Side
Category	Earthen Levee
Item	Trim / Thin Trees
View of trees and bushes within 20 feet of the shoulder blocking visibility and access.	
pkazi_f_20120913_751.jpg

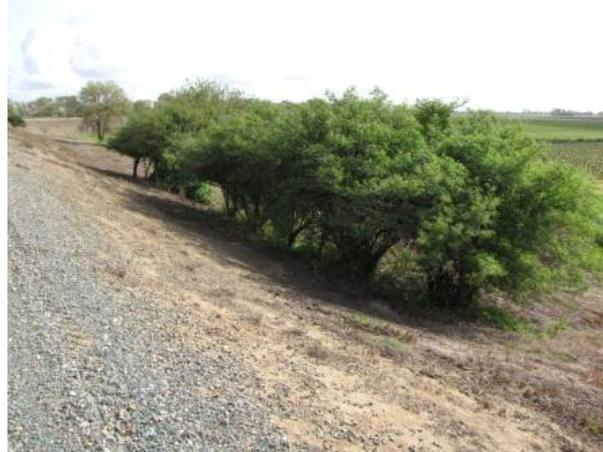
Levee Mile Report Line	9
Start Levee Mile	0.92
End Levee Mile	0.95
Location	Land Side
Category	Earthen Levee
Item	Vegetation
View of elderberries on the landward slope blocking visibility and access.	
pkazi_f_20120913_660.jpg

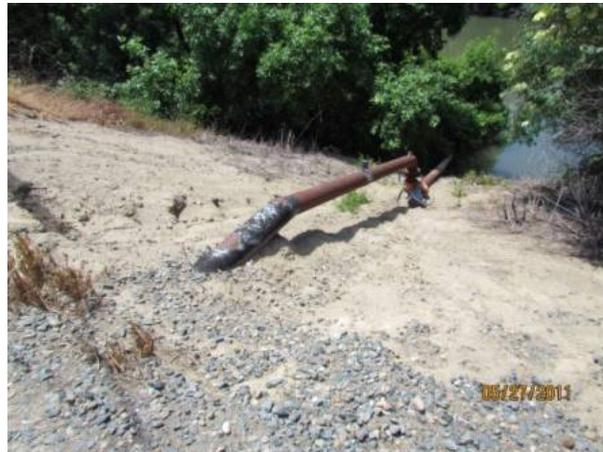
Levee Mile Report Line	12
Start Levee Mile	1.82
End Levee Mile	1.82
Location	Water Side
Category	Earthen Levee
Item	Erosion / Bank Caving
Erosion was found on the waterside slope of the levee near the vicinity of the pipe. The picture was taken from the crown looking downstream.	
pkazi_f_20120913_701.jpg

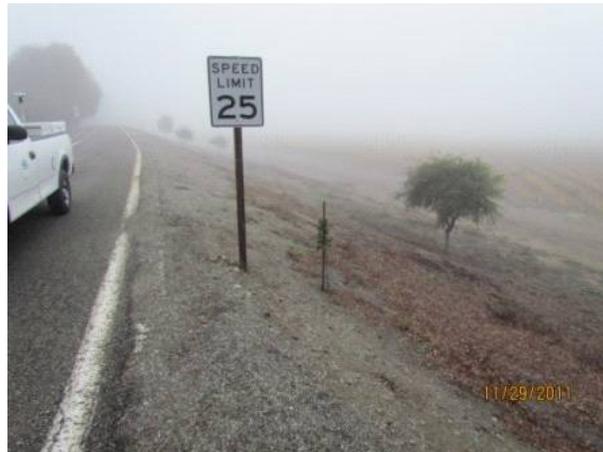
Levee Mile Report Line	13
Start Levee Mile	2.34
End Levee Mile	2.34
Location	Land Side
Category	Earthen Levee
Item	Encroachments
New tree has been planted on the landside slope of the levee looking upstream.	
pkazi_f_20120913_729.jpg

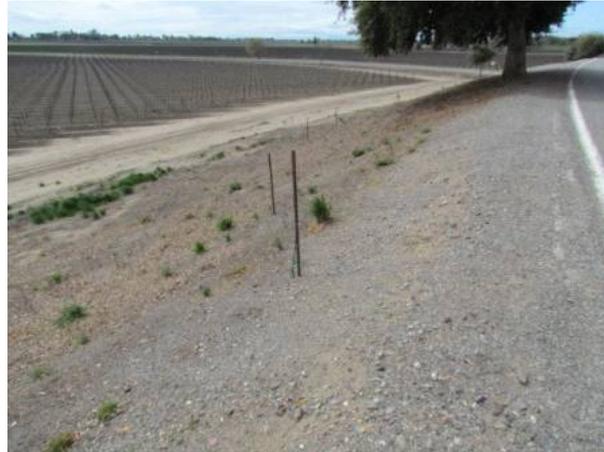
Levee Mile Report Line	13
Start Levee Mile	2.34
End Levee Mile	2.34
Location	Land Side
Category	Earthen Levee
Item	Encroachments
New tree was planted on the landside of the levee looking downstream.	
pkazi_f_20120913_730.jpg

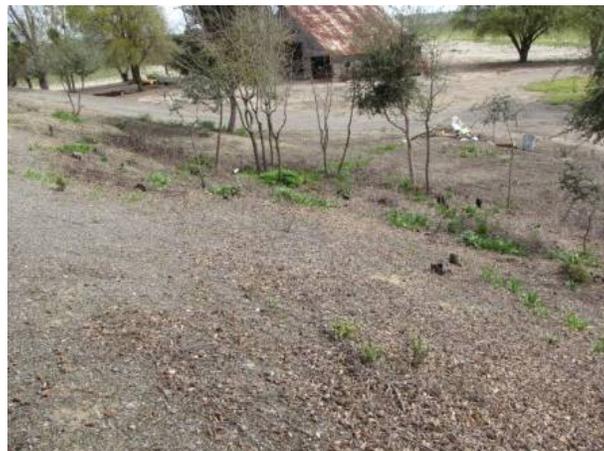
Levee Mile Report Line	15
Start Levee Mile	2.60
End Levee Mile	2.60
Location	Land Side
Category	Earthen Levee
Item	Trim / Thin Trees
View of tree stumps on the landward slope.	
pkazi_f_20120913_667.jpg

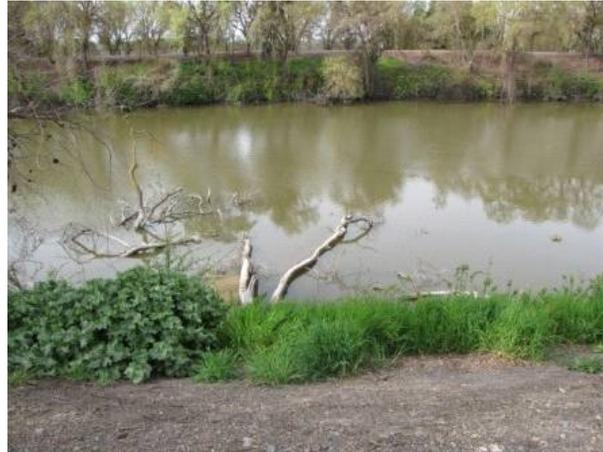
pkazi_f_20120913_674.jpg

View of tree stumps on the waterward slope.

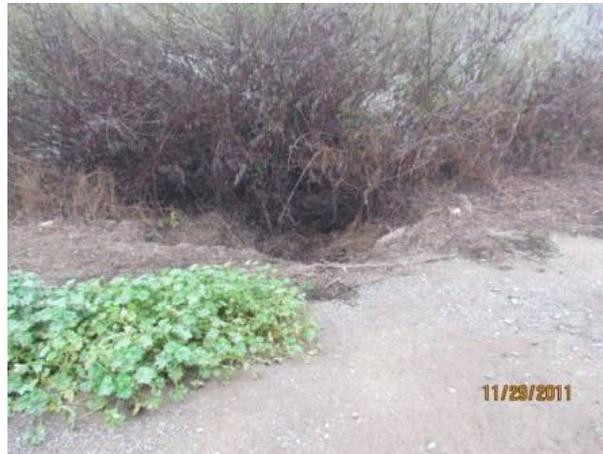
pkazi_f_20120913_727.jpg

Levee Mile Report Line	17
Start Levee Mile	2.93
End Levee Mile	2.93
Location	Water Side
Category	Earthen Levee
Item	Slope Stability

Slope instability was found on the waterside of the levee. The picture was taken from the crown looking towards the toe of the levee.

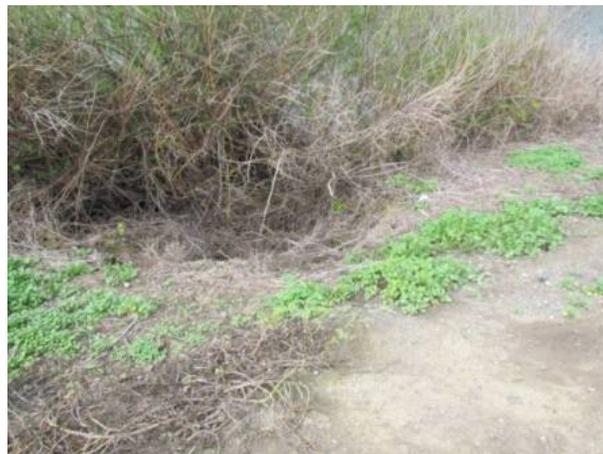
pkazi_f_20120913_728.jpg

Levee Mile Report Line	17
Start Levee Mile	2.93
End Levee Mile	2.93
Location	Water Side
Category	Earthen Levee
Item	Slope Stability

Erosion was found on the waterside of the levee looking upstream. This picture was taken during spring 2012 inspection.

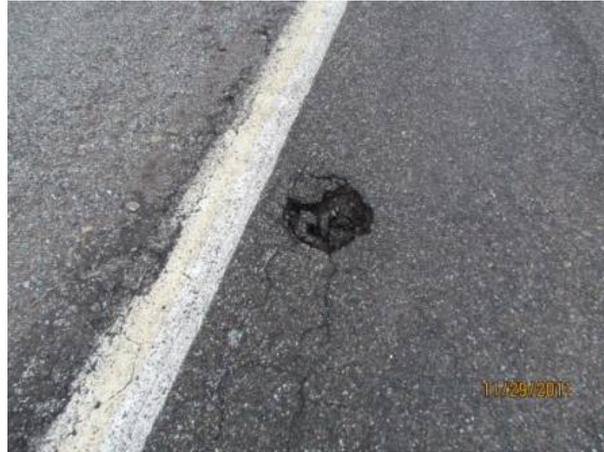
Levee Mile Report Line	18
Start Levee Mile	2.93
End Levee Mile	2.93
Location	Crown
Category	Earthen Levee
Item	Crown Surface / Depressions / Rutting
Depression was found on the crown of the levee looking downstream.	
pkazi_f_20120913_726.jpg

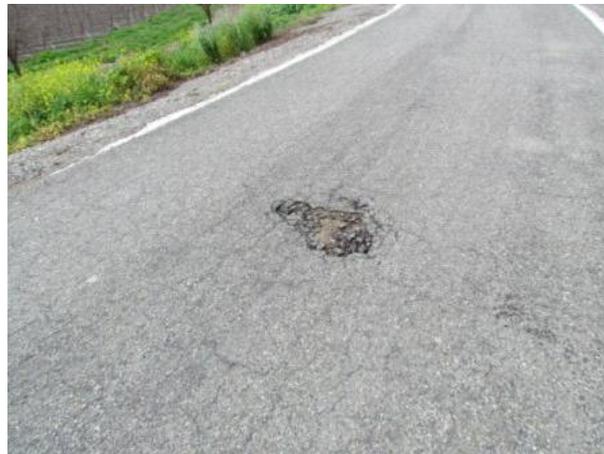
Levee Mile Report Line	19
Start Levee Mile	3.13
End Levee Mile	3.13
Location	Crown
Category	Earthen Levee
Item	Crown Surface / Depressions / Rutting
A depression was found on the crown of the levee looking downstream.	
pkazi_f_20120913_679.jpg

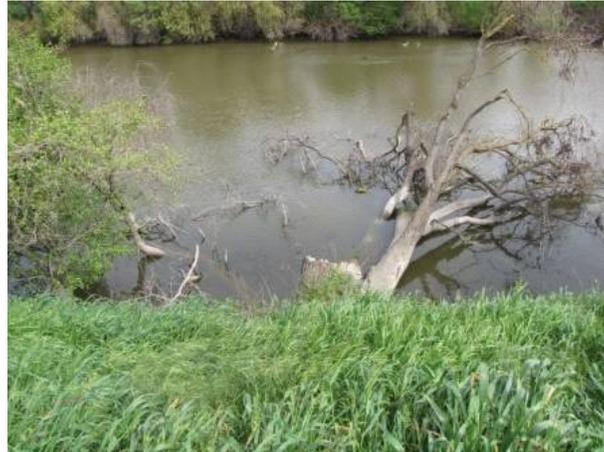
pkazi_f_20120913_677.jpg

View of tree stumps on the waterward slope.

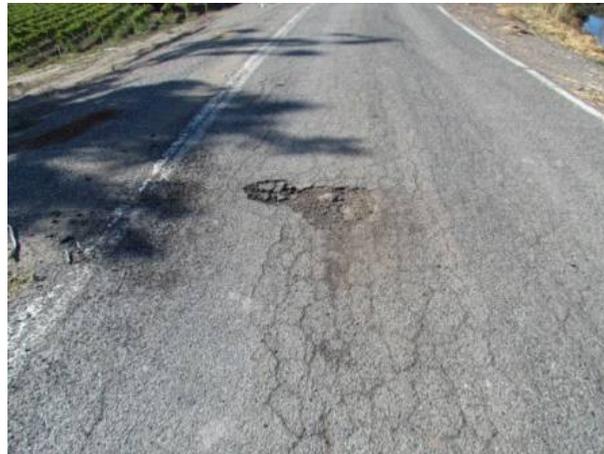
pkazi_f_20121101_997.jpg

Levee Mile Report Line	23
Start Levee Mile	3.31
End Levee Mile	3.31
Location	Crown
Category	Earthen Levee
Item	Crown Surface / Depressions / Rutting

Crown depression was found on the access road looking downstream.

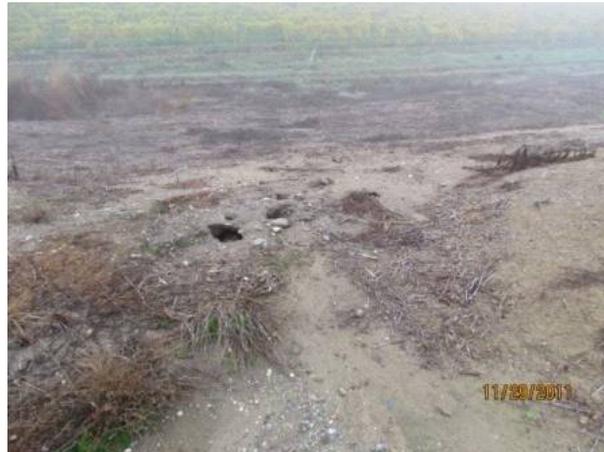
pkazi_f_20120913_722.jpg

Levee Mile Report Line	24
Start Levee Mile	3.34
End Levee Mile	3.34
Location	Land Side
Category	Earthen Levee
Item	Animal Control

Rodent holes were found on the landside of the levee looking downstream.

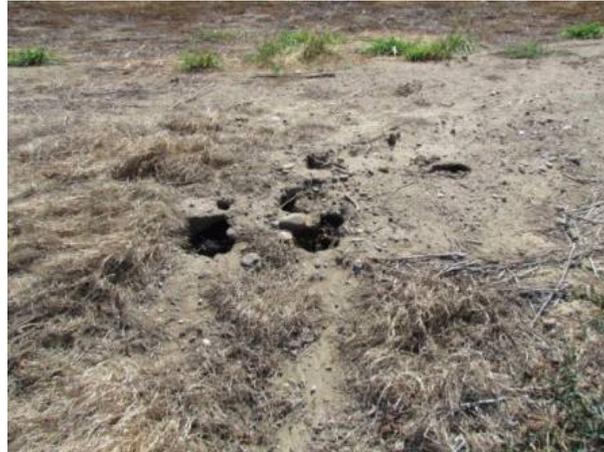
pkazi_f_20121101_996.jpg

Animal holes were found on the landside shoulder of the levee. This picture was taken from the crown looking towards the landside of the levee during fall 2012 inspection.

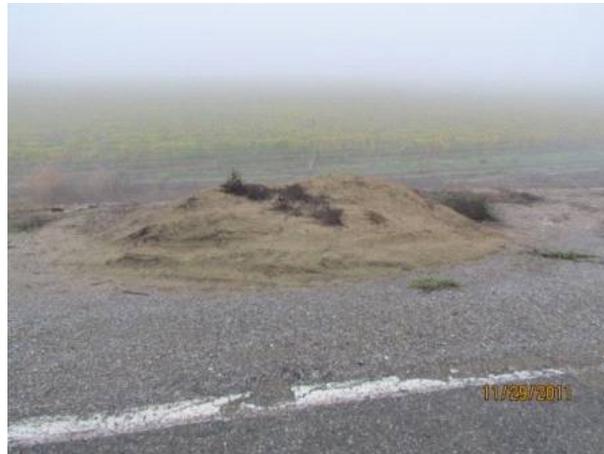
pkazi_f_20120913_723.jpg

Levee Mile Report Line	25
Start Levee Mile	3.34
End Levee Mile	3.34
Location	Land Side
Category	Earthen Levee
Item	Encroachments

Material was found on the landside of the levee looking downstream.

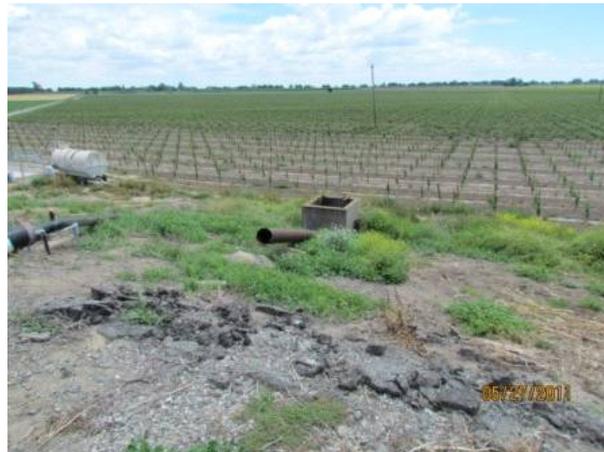
pkazi_f_20120913_691.jpg

Levee Mile Report Line	26
Start Levee Mile	3.34
End Levee Mile	3.34
Location	Land Side
Category	Earthen Levee
Item	Encroachments

An abandoned pipe was located on the landside of the levee. The picture was taken from the crown looking downstream.

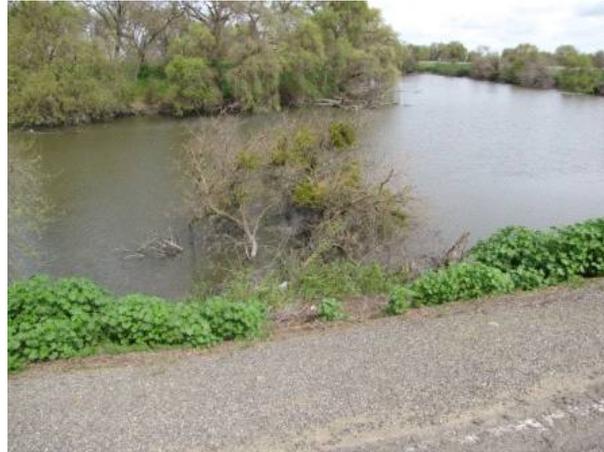
Levee Mile Report Line	27
Start Levee Mile	3.41
End Levee Mile	3.41
Location	Water Side
Category	Earthen Levee
Item	Trim / Thin Trees
View of tree stumps on the waterside slope looking upstream.	
pkazi_f_20120913_682.jpg

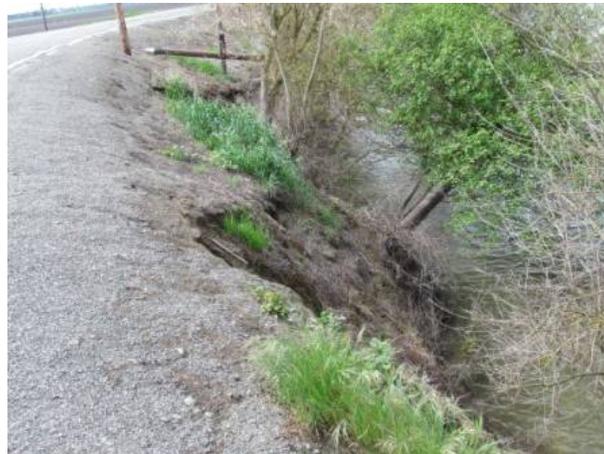
Levee Mile Report Line	28
Start Levee Mile	3.47
End Levee Mile	3.47
Location	Water Side
Category	Earthen Levee
Item	Erosion / Bank Caving
Erosion was found on the waterside of the levee looking downstream.	
pkazi_f_20120913_744.jpg

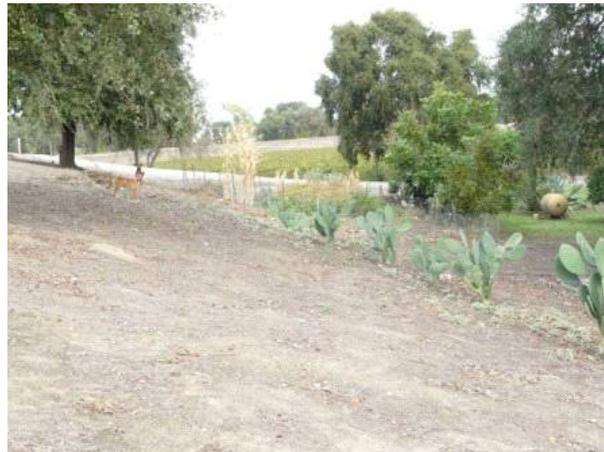
Levee Mile Report Line	29
Start Levee Mile	3.50
End Levee Mile	3.54
Location	Land Side
Category	Earthen Levee
Item	Vegetation
Landscaping & garden on landward slope of levee at LM 3.50 to LM 3.54.	
pkazi_f_20120913_696.JPG

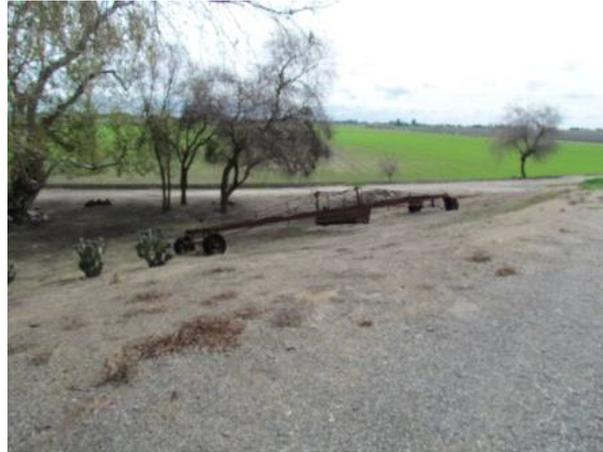
Levee Mile Report Line	30
Start Levee Mile	3.51
End Levee Mile	3.51
Location	Land Side
Category	Earthen Levee
Item	Encroachments
Equipment was found on the landside of the levee looking downstream.	
pkazi_f_20120913_743.jpg

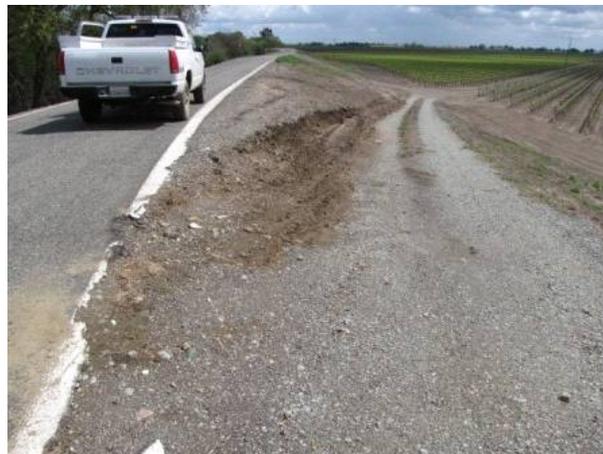
Levee Mile Report Line	31
Start Levee Mile	3.75
End Levee Mile	3.75
Location	Land Side
Category	Earthen Levee
Item	Slope Stability
Repair minor damage to levee slope along landward ramp at LM 3.75.	
pkazi_f_20120913_745.jpg

DWR ID: DWR_RD0150_03_s_2012_97										
31	3.75	3.75	Earthen Levee	Slope Stability	LS	A/W Ma	S3 : Repair the levee slope damaged by vehicle traffic and prevent access where possible.	38.367305 ° -121.554984 °	38.367305 ° -121.554984 °	927 Y
DWR ID: DWR_RD0150_03_s_2012_927										
32	3.77	3.77	Earthen Levee	Slope Stability	WS	M Ma	S2 : Repair the levee slope damaged by foot traffic and prevent access where possible.	38.367393 ° -121.554528 °	38.367393 ° -121.554528 °	15 Y
DWR ID: DWR_RD0150_03_s_2012_15										
33	3.95	3.95	Earthen Levee	Encroachments	LS	M Ma	DE : Debris	38.368118 ° -121.551509 °	38.368118 ° -121.551509 °	48 Y
DWR ID: DWR_RD0150_03_s_2012_48										
34	4.04	4.04	Earthen Levee	Crown Surface / Depressions / Rutting	LS	C Ma	C3 : Add appropriate gravel or road base. Grade and compact.	38.369455 ° -121.551616 °	38.369455 ° -121.551616 °	95 Y
DWR ID: DWR_RD0150_03_s_2012_95

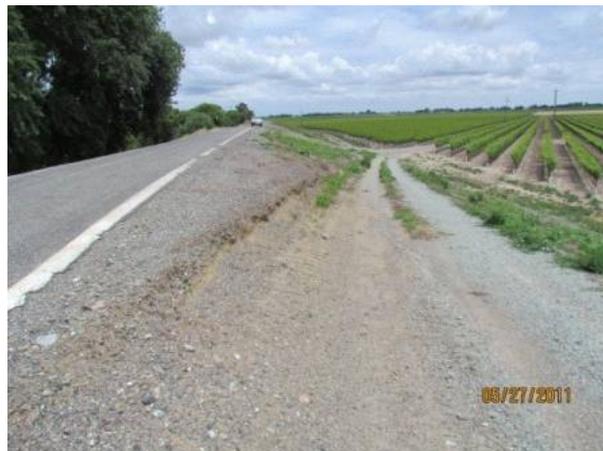
Levee Mile Report Line	31
Start Levee Mile	3.75
End Levee Mile	3.75
Location	Land Side
Category	Earthen Levee
Item	Slope Stability
Slope instability possible due to vehicular traffic on the landside of the levee. The picture was taken from the crown looking upstream during Spring 2011 inspection.	
pkazi_f_20120913_746.jpg

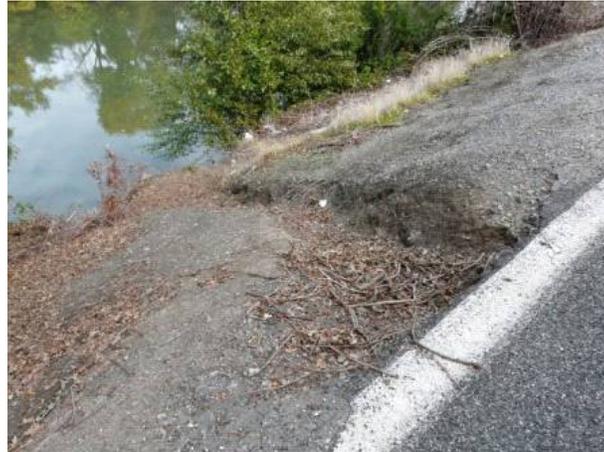
Levee Mile Report Line	32
Start Levee Mile	3.77
End Levee Mile	3.77
Location	Water Side
Category	Earthen Levee
Item	Slope Stability
Repair slope damaged by foot traffic at LM 3.77.	
pkazi_f_20120913_671.JPG

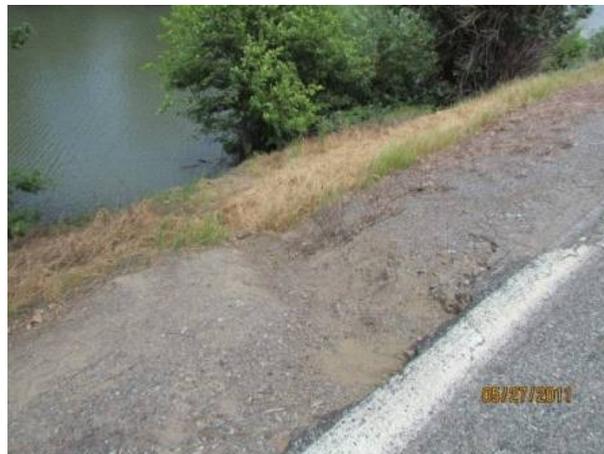
Levee Mile Report Line	32
Start Levee Mile	3.77
End Levee Mile	3.77
Location	Water Side
Category	Earthen Levee
Item	Slope Stability
Updated picture of the erosion on the waterside slope of the levee during Spring 2011 inspection.	
pkazi_f_20120913_672.jpg

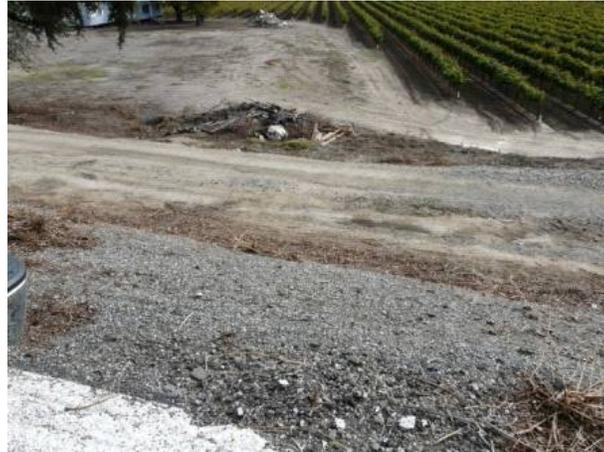
Levee Mile Report Line	33
Start Levee Mile	3.95
End Levee Mile	3.95
Location	Land Side
Category	Earthen Levee
Item	Encroachments
Debris pile on landward slope at LM 3.95.	
pkazi_f_20120913_697.JPG

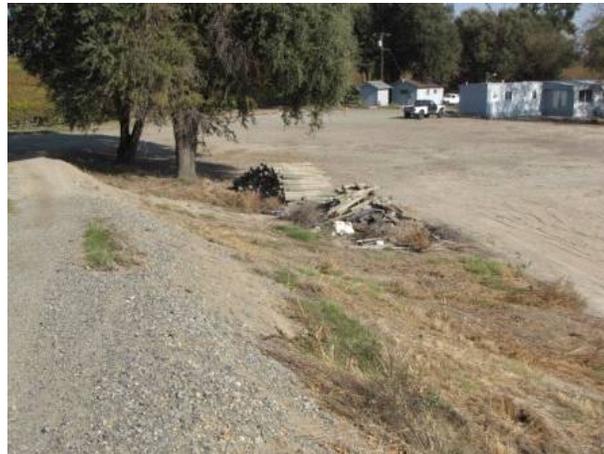
Levee Mile Report Line	33
Start Levee Mile	3.95
End Levee Mile	3.95
Location	Land Side
Category	Earthen Levee
Item	Encroachments
Updated view of material piled at the toe of the levee as of fall 2009.	
pkazi_f_20120913_698.jpg
